SET 1. Step-in development pictures of a hidden leakage event.

SET 2. Step-in development pictures of a hidden leakage event.

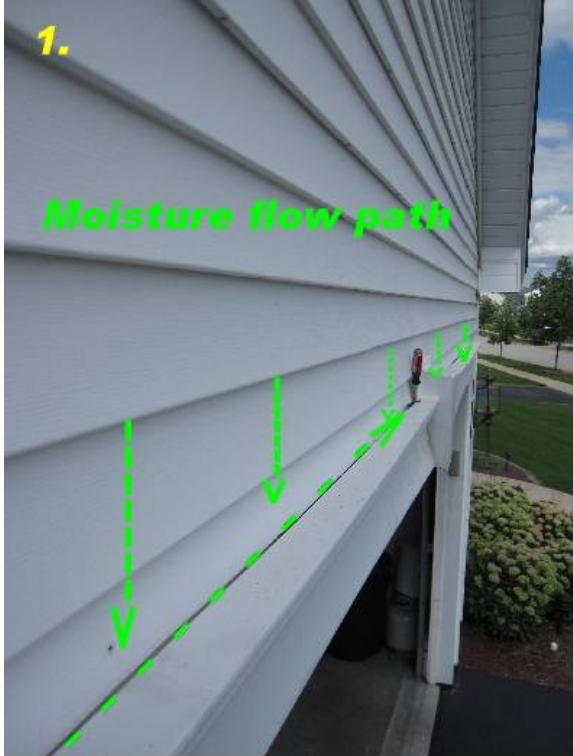
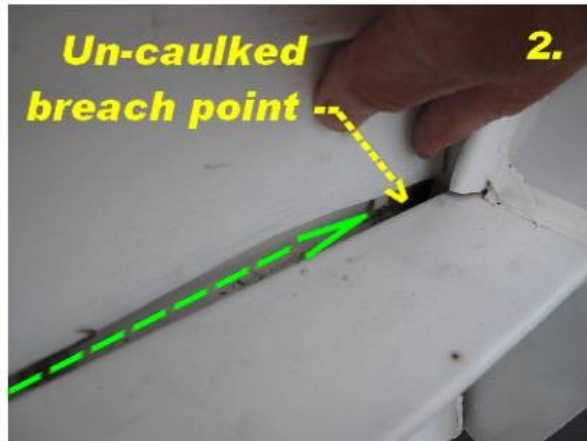
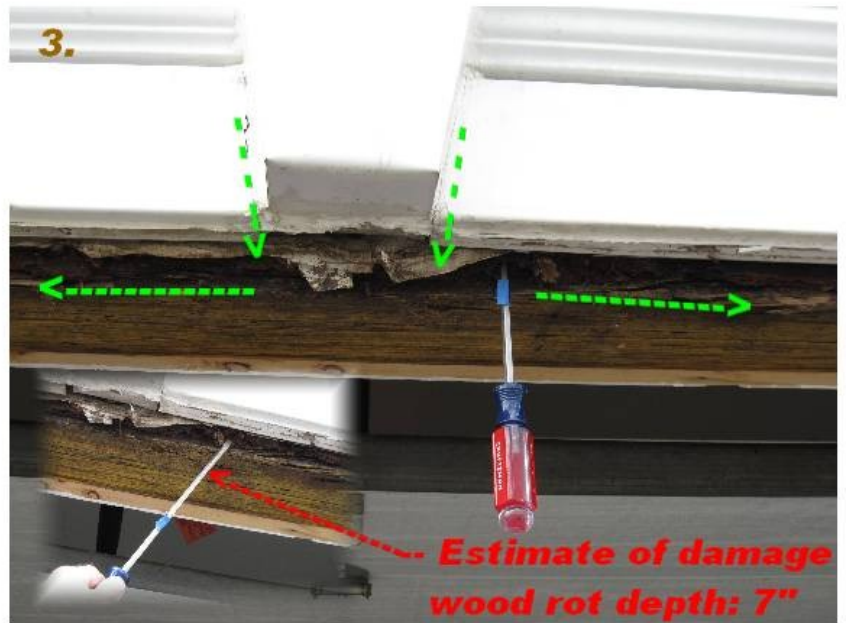
SET 3. Step-in development pictures of a hidden leakage event.

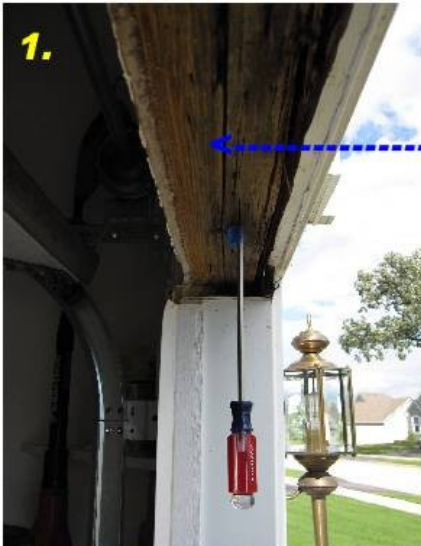
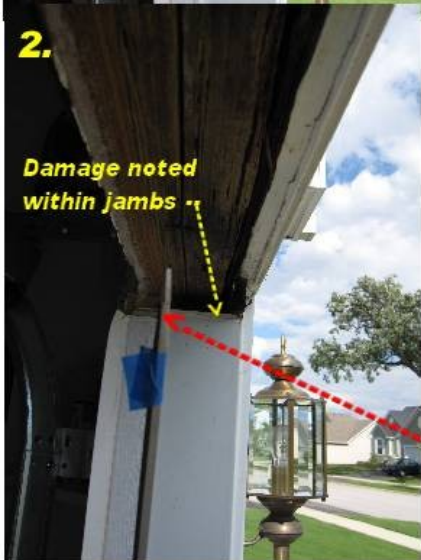
**Load bearing twin LVL
garage header support**

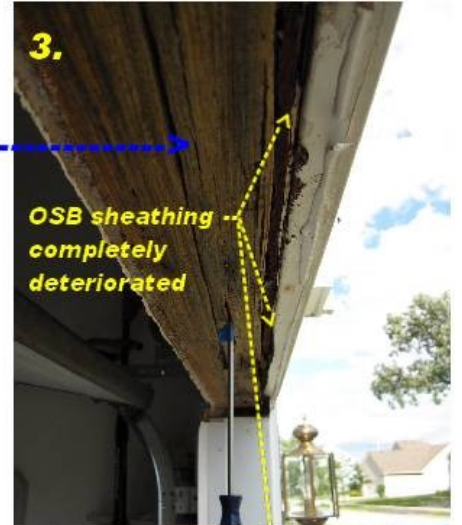
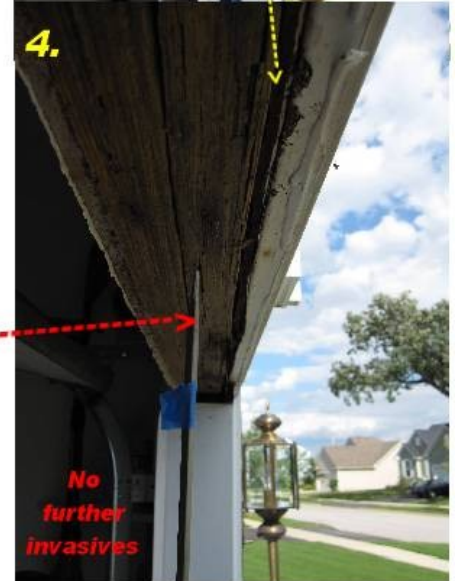
SET 4. Step-in development pictures of a hidden leakage event.

**Estimate of damage
wood rot depth: 3"**

**Estimate of damage
wood rot depth: 2"**

**No
further
invasives**

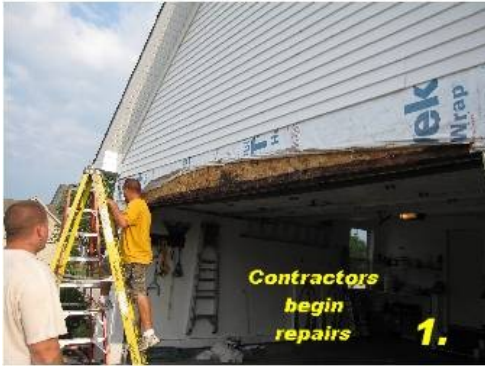
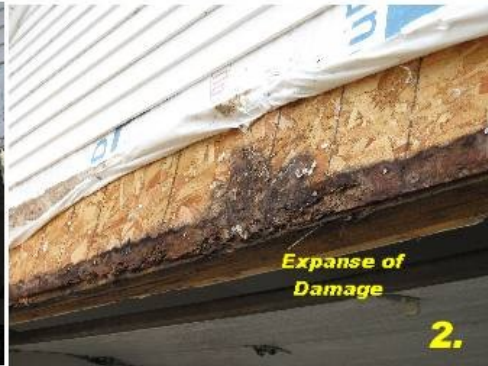
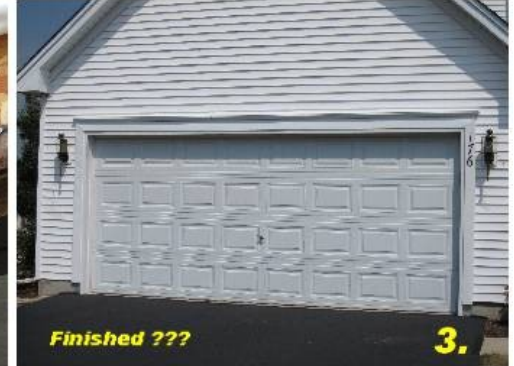
Architectural key stone left out. It was determined as the main factor causing the leakage event.

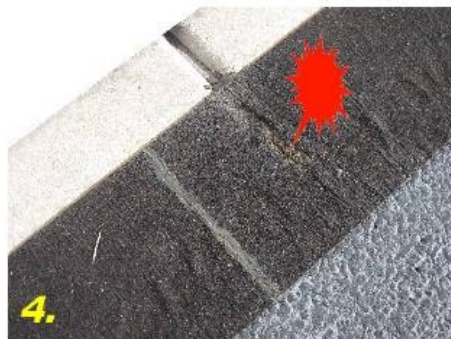
<----- Indications that internal leakage is still occurring.
