Contact: Mr. Kevin Cuyler
 Project: 9310-TL-1
 Date of Sampling: 09-03-2010
 Date of Receipt: 09-03-2010
 Date of Report: 09-07-2010

MoldREPORT

Detailed Results of Surface Sample Analysis

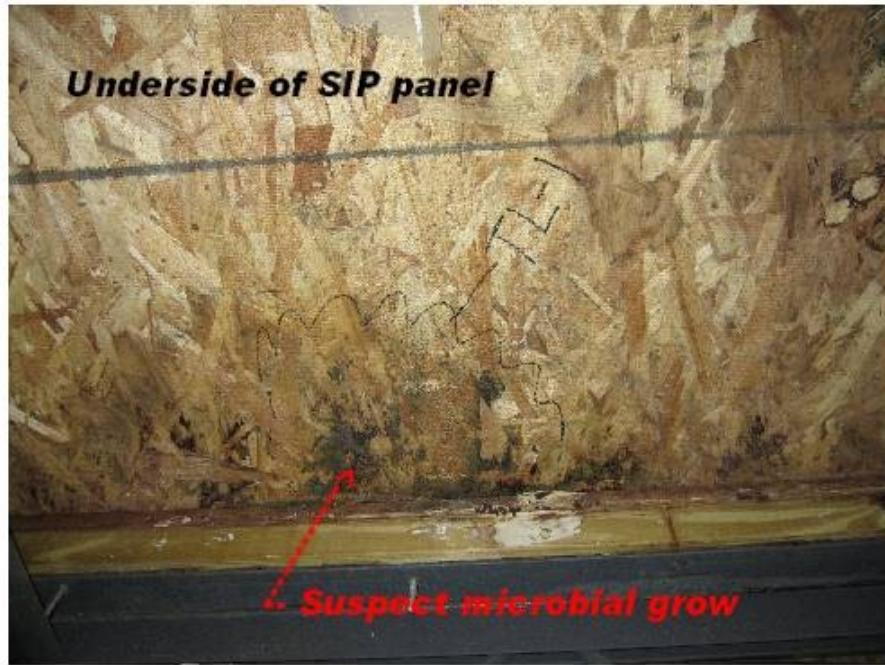
Sampling Location

Location:	1: TL-1 Lab room underside sip.				
Sample Type:	Tape sample				
Mold growth present*: Low=small amounts of mold growth present High=large amounts of mold growth present	No growth found	Low			High
Acremonium species					
Alternaria species					
Aspergillus species					
Aureobasidium species					
Chaetomium species					
Cladosporium species					
Colorless spores typical of Penicillium/Aspergillus					
Penicillium species					
Stachybotrys species					
Trichoderma species					
Ulocladium species					
Miscellaneous spores present: Indicative of normal conditions**	Very few				
Background debris:	Light				
Other comments:	Analysis of replicate sample is delayed.

Attached are the **EM Labs P&K MoldREPORT** lab results for the SIP's panel direct microscopic tape lift sampling test, and the annotated reference picture from where the sample was acquired. The lab reports **high mold growth** findings. The lab indicates *Chaetomium* as the predominant mold species for TL-1 sampling. *Chaetomium* is considered a serious "wet" mold with a wide range of ill affects on people, thus exposure to it should be avoided and professional protocols of remediation to remove it should be employed. Please review page 5 of 12 for explanations. As stated there, "the growth should be physically removed by professional means and the source of moisture intrusion corrected." Please review the **MoldREPORT** in its entirety, as well as **Go Above Board's Point Specific Assessment** sent prior.

Sampling location of TL-1, Lab Room
